NRL/MR/6110--01-8561

Report of Green Thread Pipe Installation at Lualualei, HI and Jim Creek, WA VLF Sites: Changes from 1997 to 2001

ROBERT A. LAMONTAGNE

July 12, 2001

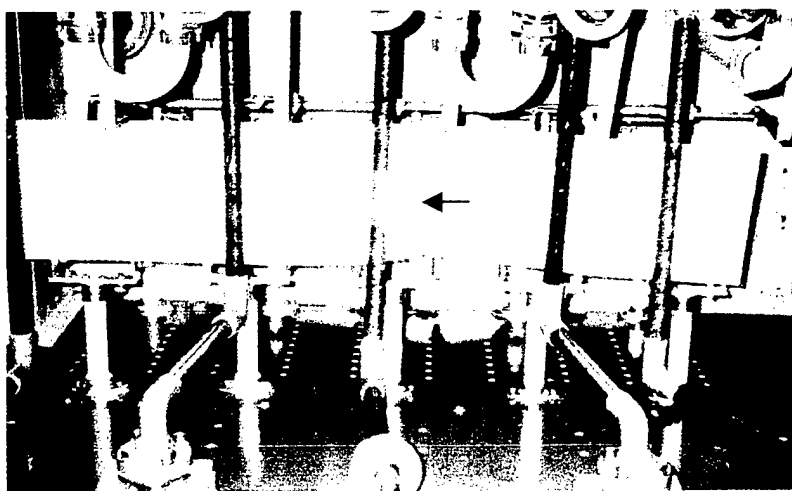
Figure 1. 1998 Photograph of the fiberglass pipe for PA 2 showing the color variations change in 1998 for PA2.

The coloration of the fiberglass pipe was photographed for use in future assessments of the aging process of the fiberglass pipe under VLF operating conditions. The discoloration of the pipe was mapped for all the cabinets. Figure 1 shows the color variations obtained for PA 2 in 1998. In general, the outlet pipes have a darker amber color than the inlet side pipes, but there were significant variations in the color for both inlet and outlet due to the variations in batch production of the pipe. There appeared to be color discontinuities in some of the piping where a splice has been used to join two pieces of pipe (indicated by arrow).

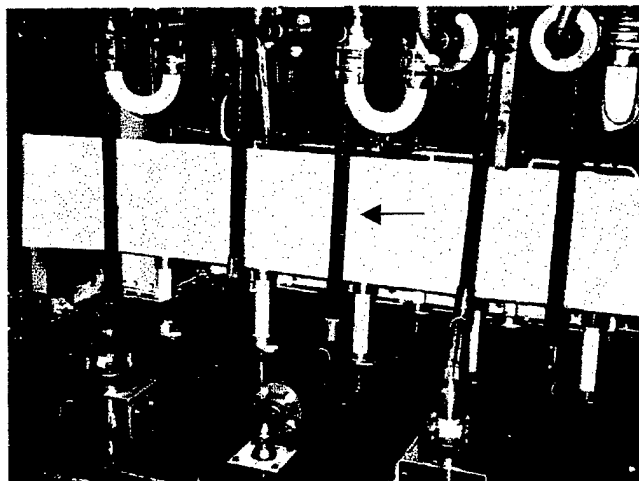
Figure 2 shows the same section of pipe (PA 2 left) photographed in March 2001. It is obvious that the Green Thread pipe has aged to a relatively uniform amber to dark amber color. There is no yellow green pipe coloration in the PA cabinets. Appendix A shows color changes of the Green Thread pipe for several PA cabinets for 1998, 2000, and 2001.

Figure 2. 2001 Photograph of the fiberglass pipe for PA 2 showing the color variations.

The arrow in figure 2 denotes the location of the splice indicated in figure 1. The overall color of the latest photographs are darker than the earlier photographs, yet they portray a relatively true color change for the Green Thread pipe. Appendix A contains photographs showing selected color change from 1998, 2000 and 2001 for Lualualei and Jim Creek.

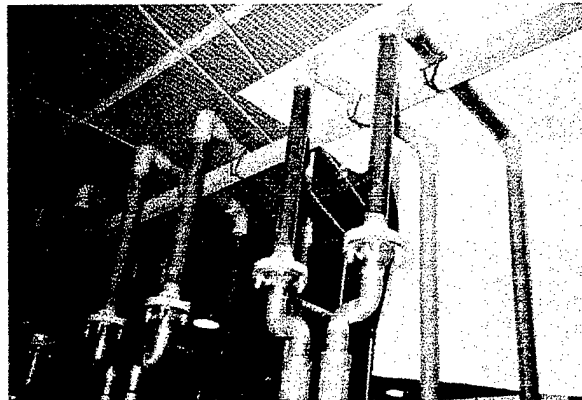
The fiberglass pipe (figure 3) was installed in February 1997 and had been in service for approximately 13 months (May 1998). The upper summer time operating temperature for the cooling water is approximately 110°F. The color variations in the fiberglass pipe at that time were less intense at Jim Creek than those at Lualualei, HI. Once again, the

Figure 3. 1998 photograph of fiberglass pipe discoloration for 13V1001 (starboard side).

variations in color adhere to the rule that the warmer the pipe (i.e., higher temperature of the cooling water) the darker the color. However, similar to the Lualualei site, there are

of pipe immediately attached to the exit flange, the next segment of pipe is dark amber and the remaining segment of pipe is light green/amber. The explanation is probably in the quality control of the fiberglass pipe batches, pipe age and ambient temperature of the situation. As can be seen in figures 3 and 4, the color of the fiberglass pipe has darkened slightly but retained the same color differentials. It may take a very long in service time (many years) before the Jim Creek site fiberglass pipe obtains a relatively even dark color like Lualualei.

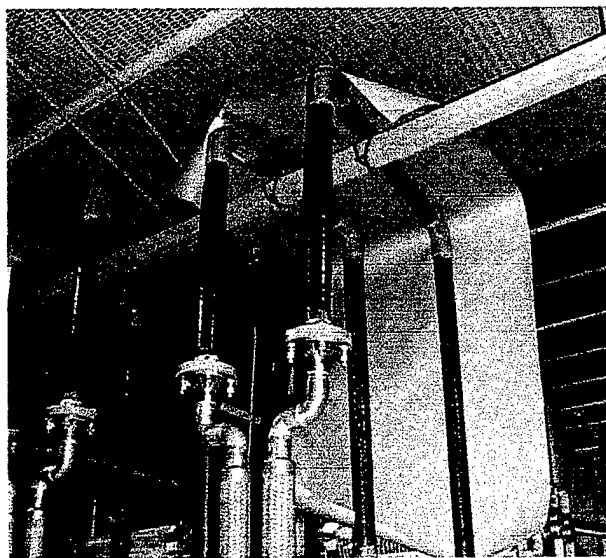
Figure 4. 2001 photograph of the fiberglass pipe discoloration for 13V1000 (starboard side).

light green/amber fiberglass pipe on the hotter exiting water with multiple variations to the general color distribution. There are cases where there is a light green/amber section

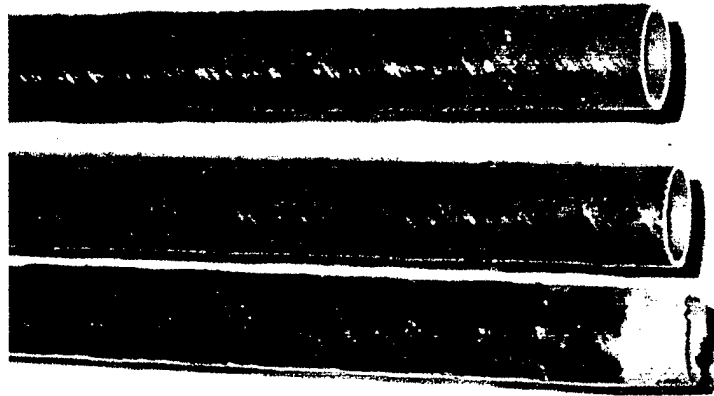
Figure 5 shows how different the color changes can be obtained for the Green Thread pipe over a period of time. Several pieces of Green Thread pipe were stored in

Figure 5. Green Thread pipe stored in warehouse at Lualualei site, March 2001.

the warehouse away from the transmission site at Lualualei. The temperature in the storage building at Lualualei was in the high 90s in March 2001. There apparently

is no air conditioning in that building. We have an example of amber, light amber and close to the original medium yellow-green color. In contrast, several pieces of fiberglass

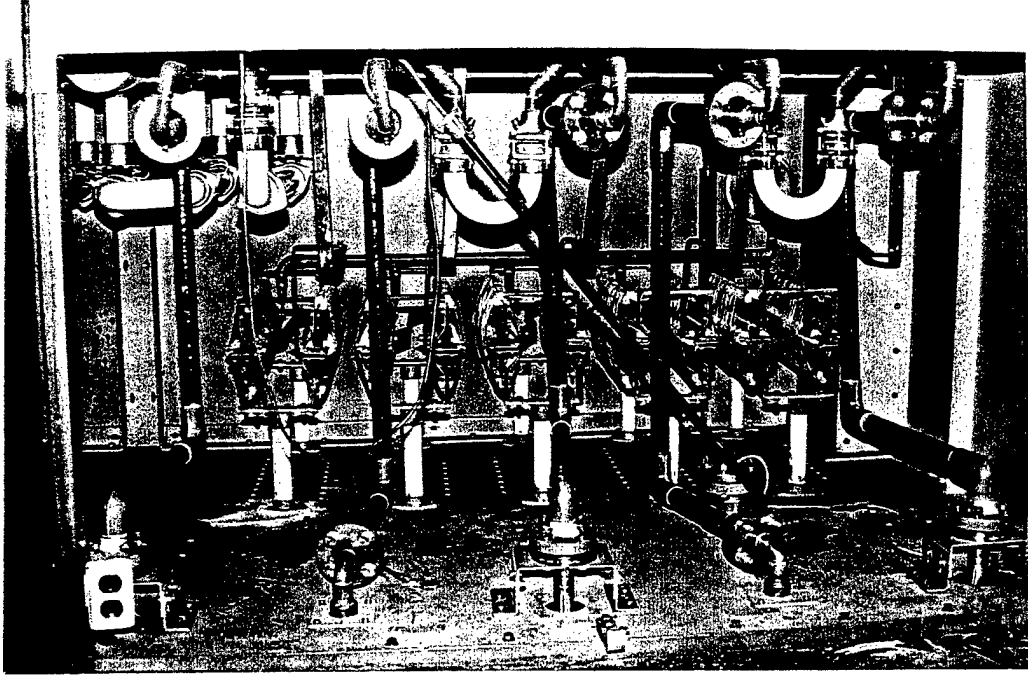
Figure 1. 1998 photograph of PA 1 (right side) fiberglass pipe showing color variations.

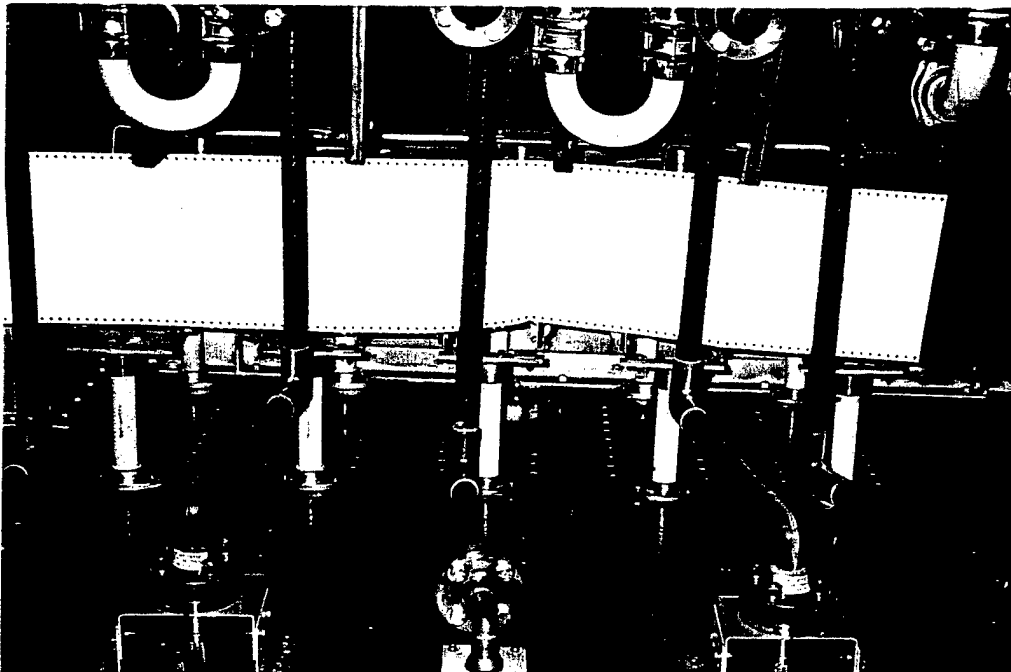
Figure 2. 1998 photograph of PA 2 (left side) fiberglass pipe showing color variations. Discontinuity of color in center pipe probably due to splice.

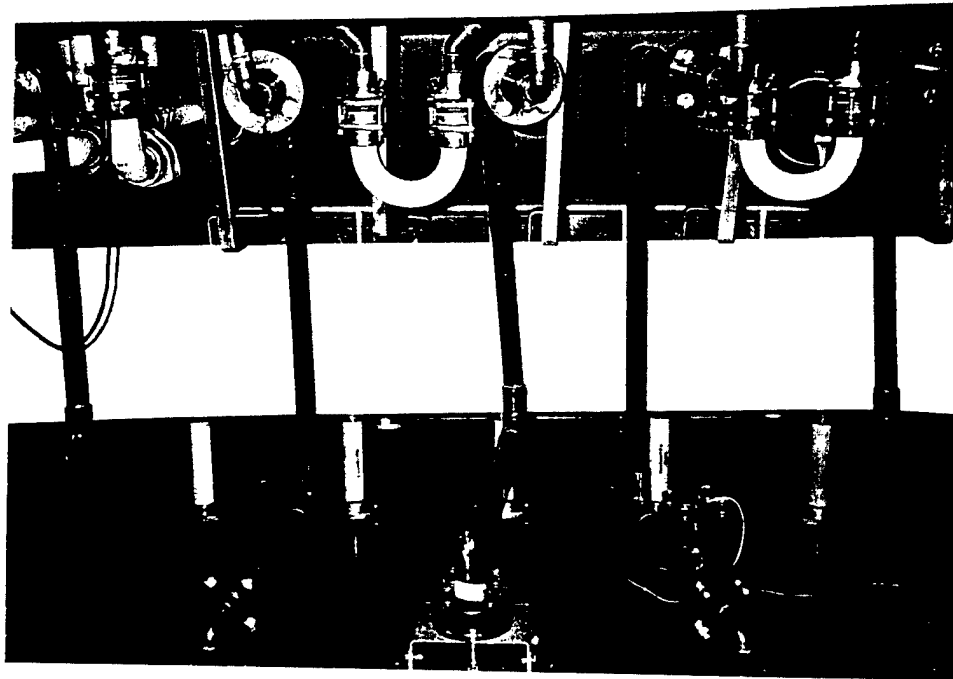
Figure 3. 2000 photograph of PA 1 (right side) fiberglass pipe showing that the color variations are almost nonexistent.

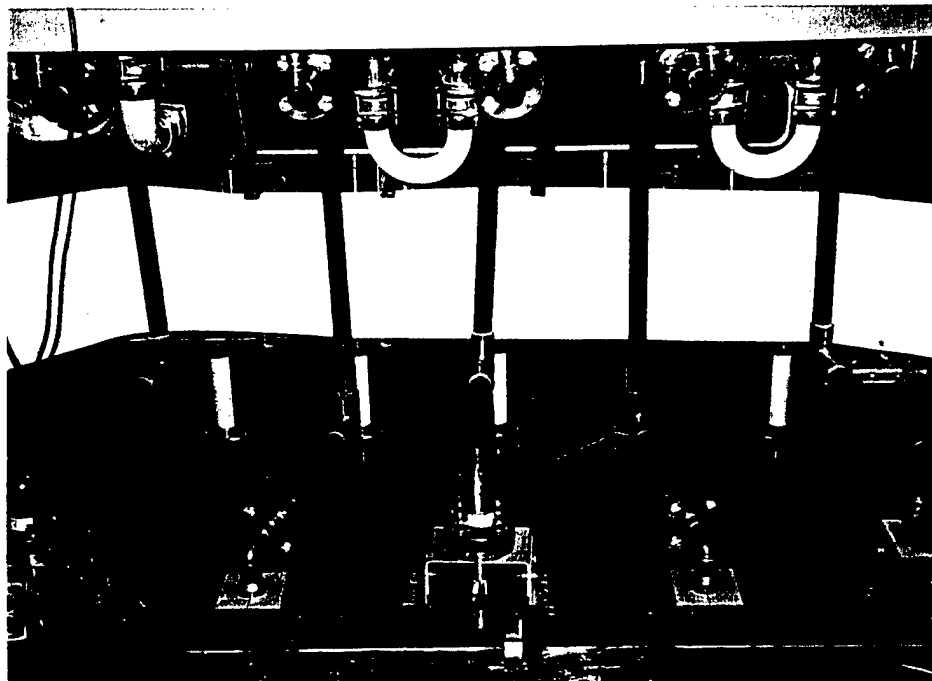
Figure 4. 2000 photograph of PA 2 (left side) fiberglass pipe showing color variations. Discontinuity of color in center pipe shown in figure 2 is not evident now.

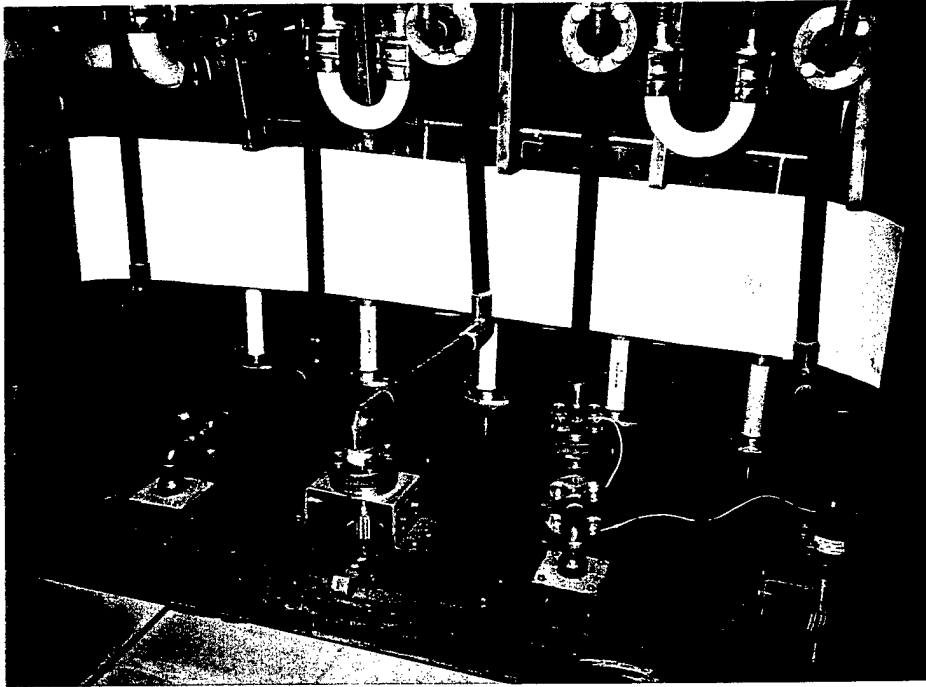
Figure 5. 2001 photograph of PA 1 (right side) fiberglass pipe showing that the color variations are almost nonexistent.

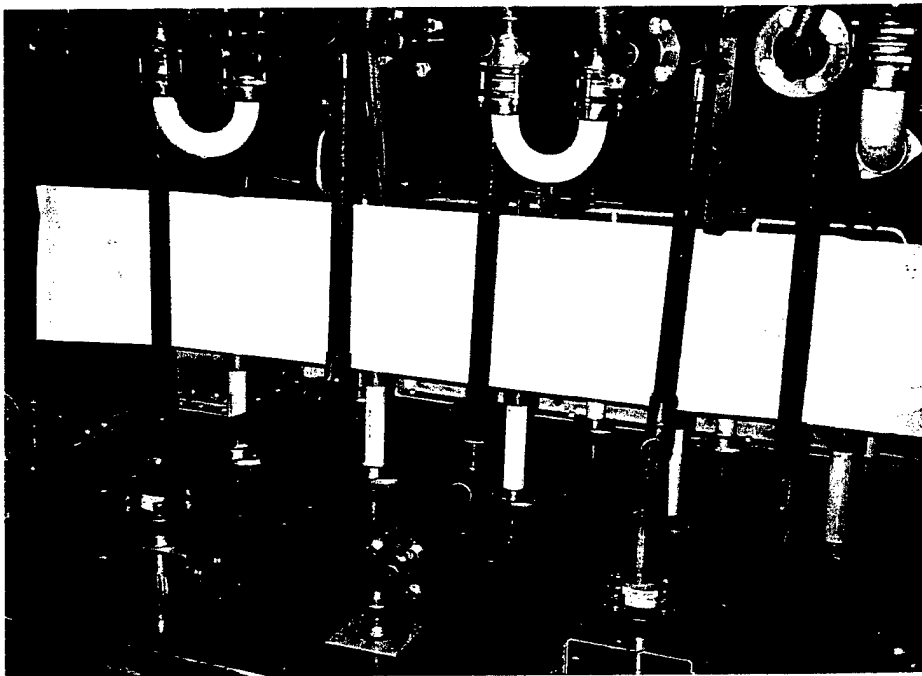
Figure 6. 2001 photograph of PA 2 (left side) fiberglass pipe showing no color variations.

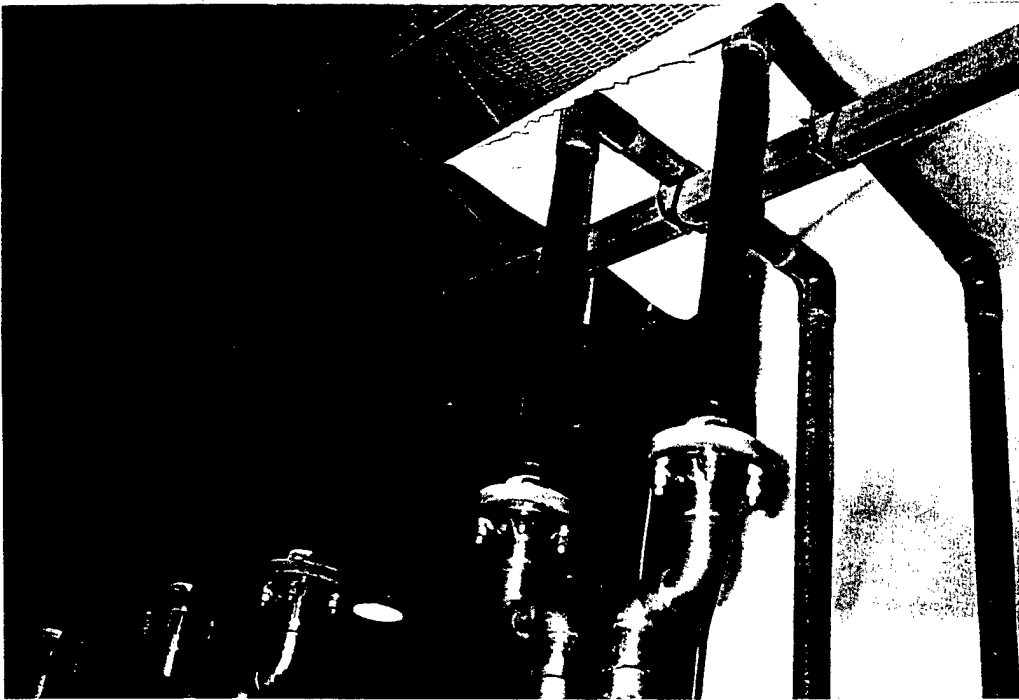
Figure 7. 1998 photograph of fiberglass pipe discoloration for 13V1001 (starboard side).

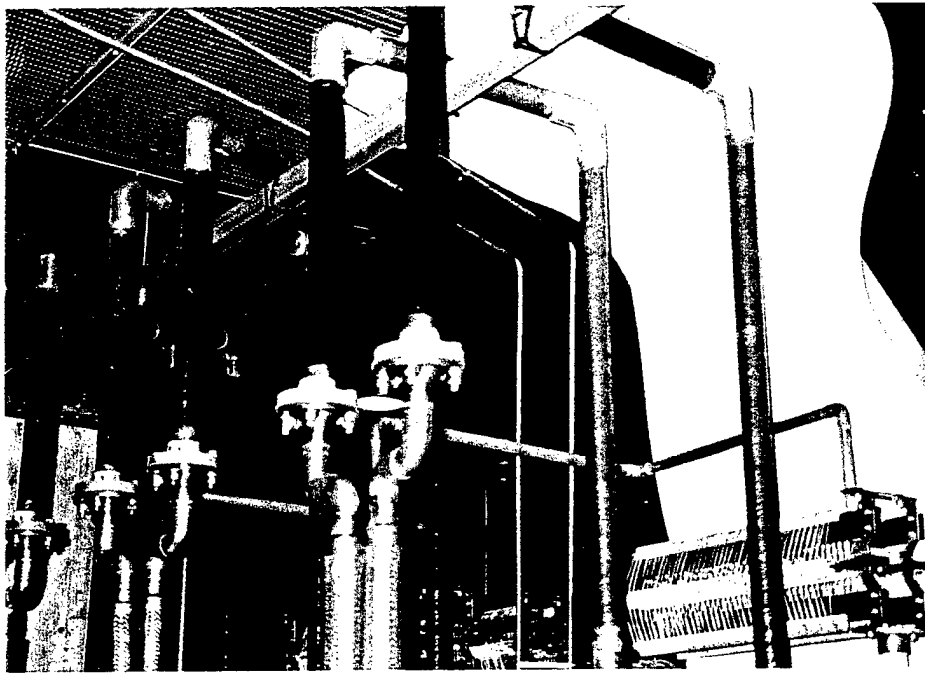
Figure 9. 2000 photograph of fiberglass pipe discoloration for 13V1001 (starboard side)

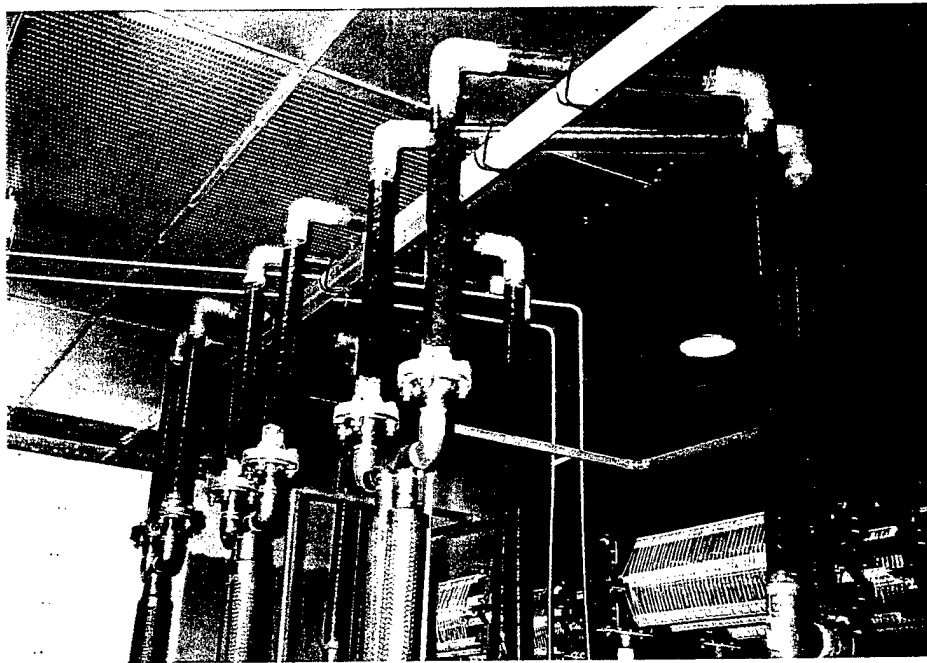
Figure 10. 2000 photograph of fiberglass pipe discoloration for port side PAs.

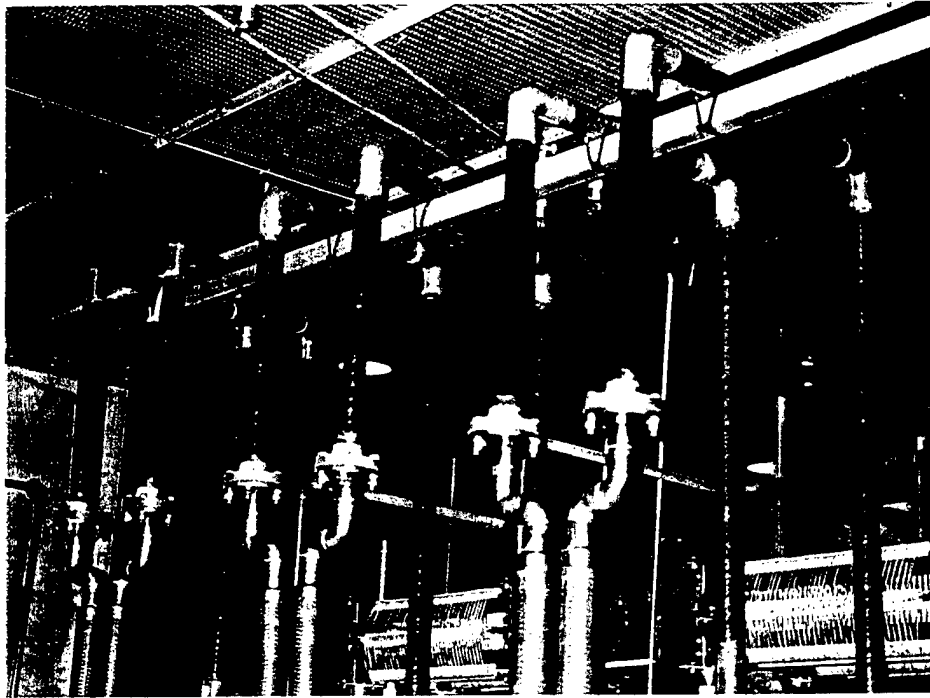
Figure 11. 2001 photograph of fiberglass pipe discoloration for 13V1001 (starboard side).

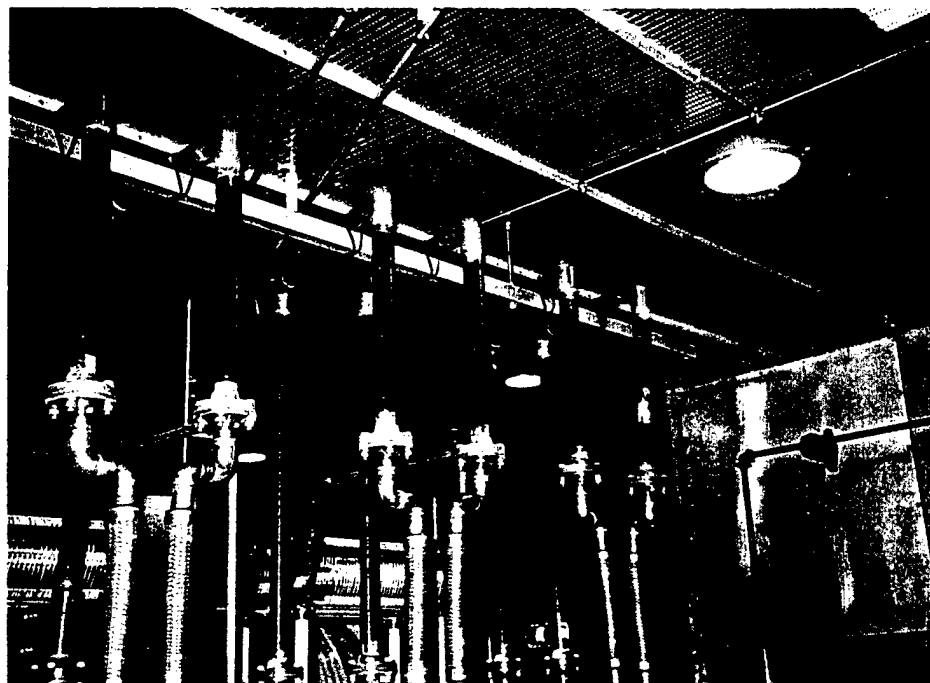
Figure 12. 2001 photograph of fiberglass pipe discoloration for portside PAs.
